# Inspection Report

## Acme home inspection

Property Address  
215 Bonbrook Dr Wabash, IN

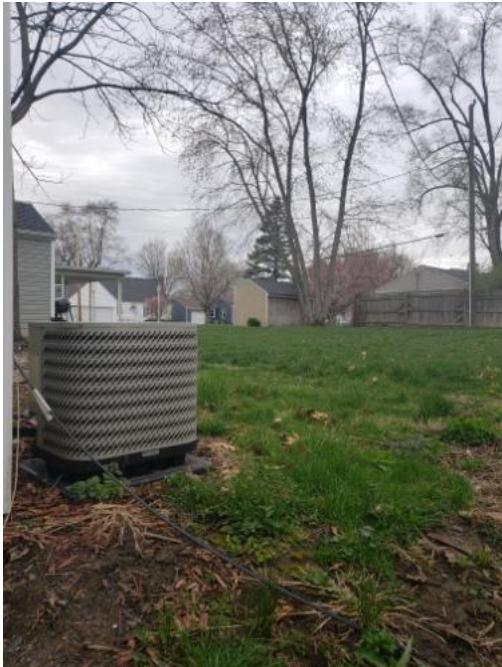
#### 1.1) Grading Conditions

Grading was sloped away from the house sufficiently on all sides except the northside of house where the grading was flat to slightly negative. This could be improved with a drainage installation.

Evidence of poor site drainage or grading was observed at northside of house.

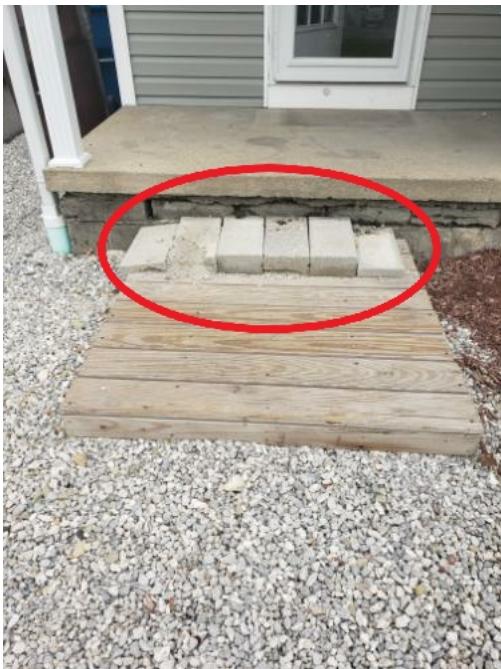
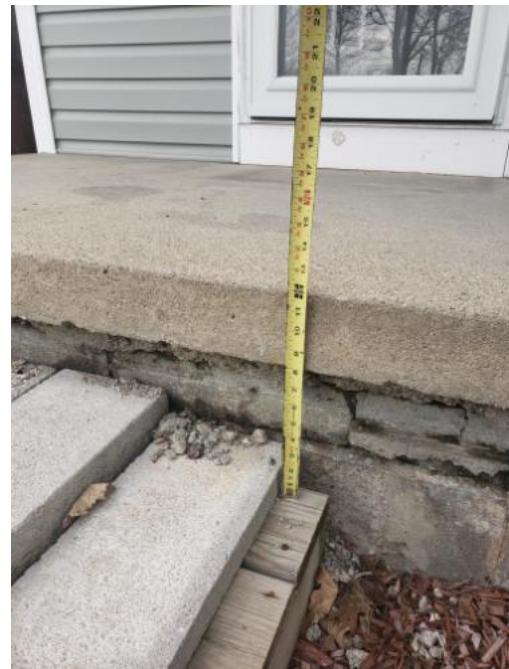
#### 1.3) Sidewalk Conditions

The walkway is wood with concrete blocks for steps. Block steps are deteriorated and not tall enough. Both situations present a trip hazard. Recommend replacing blocks with something taller that would evenly split the 12" rise from walkway to porch surface. Maintenance is recommended on a regular basis to reduce moisture related deterioration of the wood walkway.

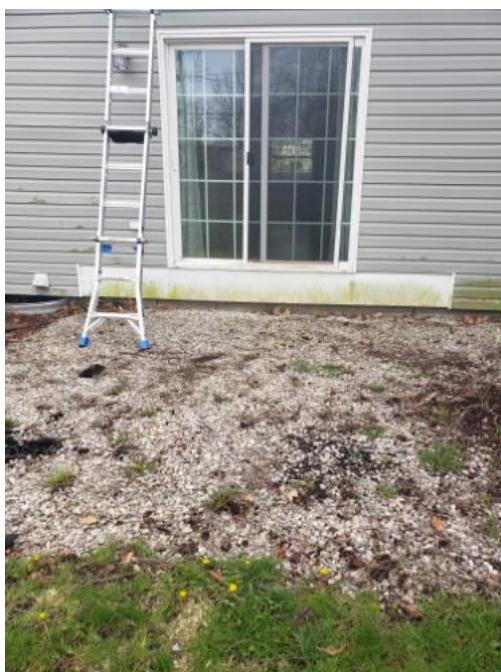
**2.2) Back Entrance Conditions**

No rear entrance, as deck has been removed.

Recommend replacing deck or adding steps to make this entrance/egress safe.

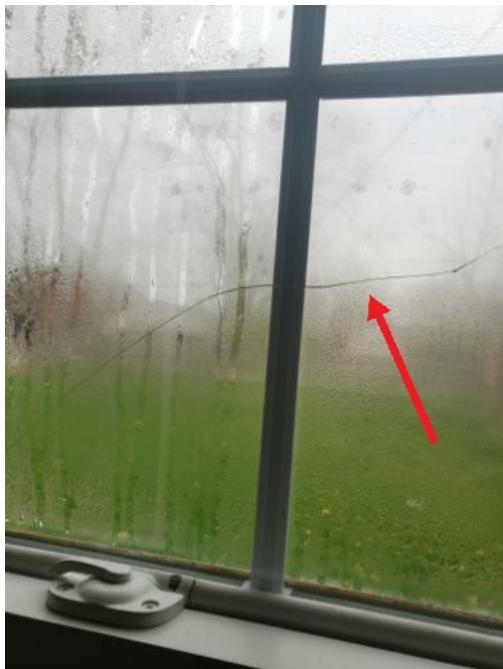
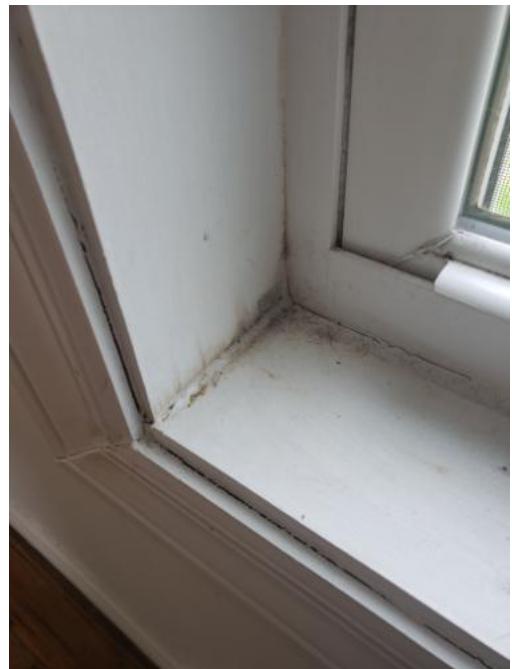
Northeast bedroom

Broken glass pane was observed in northeast bedroom . Recommend repair as needed. Also noted staining in the sill corners of several windows. These areas were not damp at the time of inspection. Recommend monitoring during rainy conditions and resealing or having window professional evaluate further if dampness is noticed.

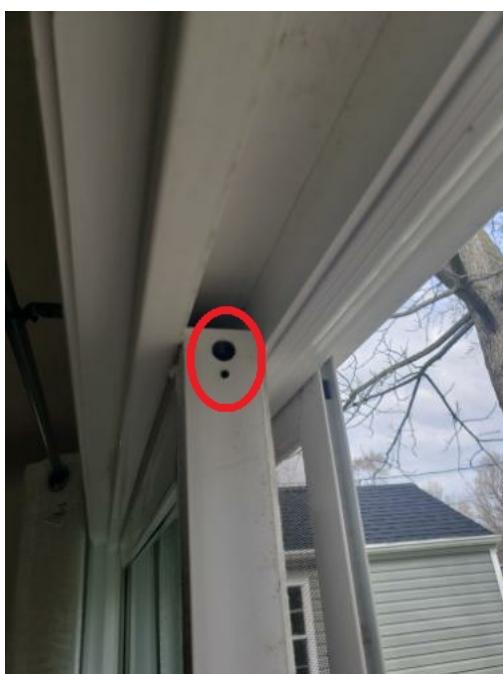
#### 2.5) Exterior Door Conditions

The rear sliding door appeared to be missing hardware at the top. Although door did close and latch properly this condition allowed door to rock in frame when opening and closing. A video demonstrating this condition has been sent to: [brian\\_northwood90@gmail.com](mailto:brian_northwood90@gmail.com) - Recommend repair or replacement of door.

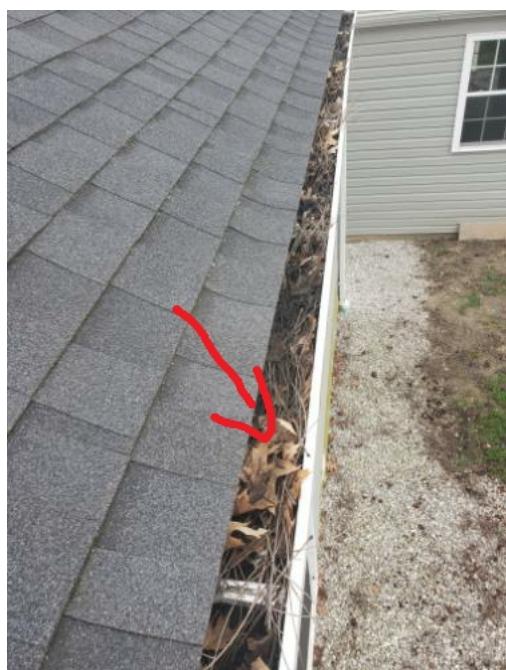
### 3.3) Gutter & Downspout Conditions

The gutters were filled with leaves and debris at the time of the inspection. Suggest cleaning and removal of debris on a regular basis. This condition can cause water penetration at the eave area and foundation issues.

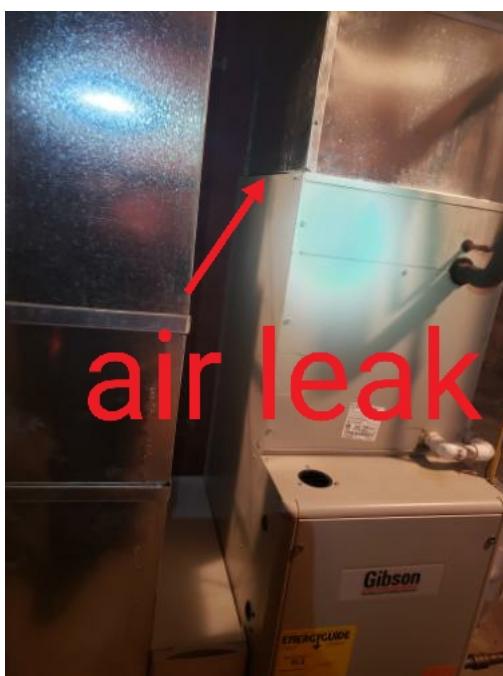
#### 4.1) Unit Conditions

Air leak in distribution plenum, making noise and likely dispersing unfiltered air into dwelling.  
Recommend installation of sheet metal screw at this location to remedy situation. a video demonstrating this condition has been sent to: [brian\\_northwood90@hotmail.com](mailto:brian_northwood90@hotmail.com)

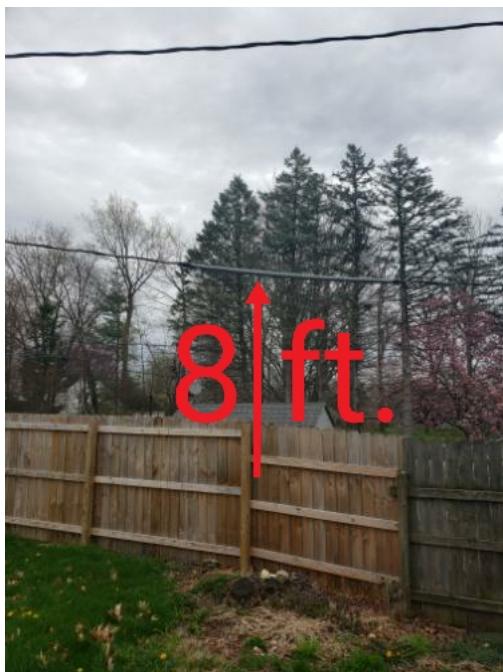
#### 5.1) Electrical Service Conditions

Neighbor's electrical service passes over this property at only 8 feet above grade. This is too low and a safety hazard. Correction by neighbor or utility company should be requested .

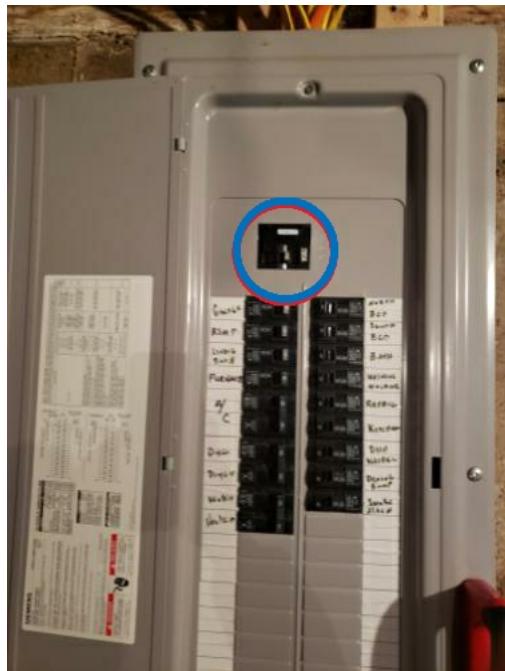
Main disconnect

**Main Disconnect Location** At Main Panel.

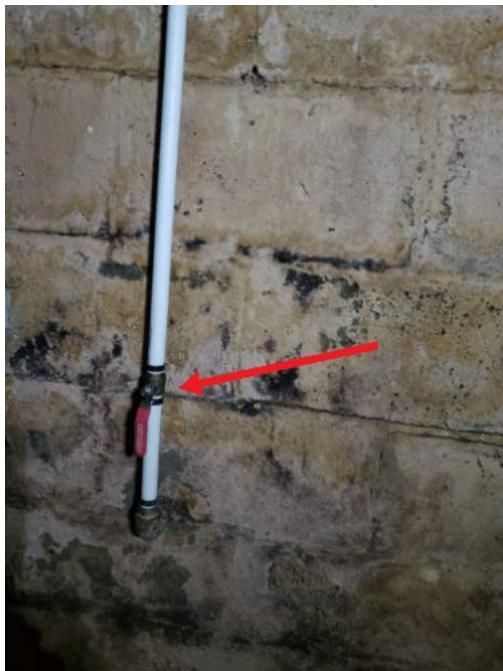
Main water shutoff

The main valve is located at the basement. (West basement wall).

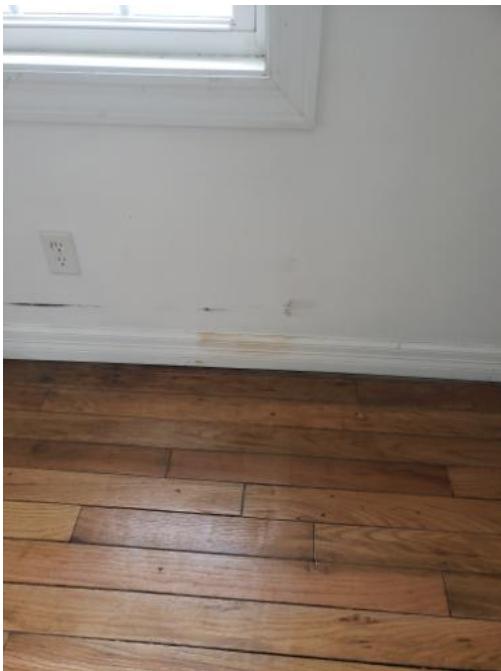
#### 7.1) Wall Conditions

One isolated moisture stain below bedroom window. Was not moist at time of inspection. Possibly an old stain caused by a formerly installed window a/c unit or faulty window. Wood flooring below this window was also buckled. Monitor for future moisture in this area.

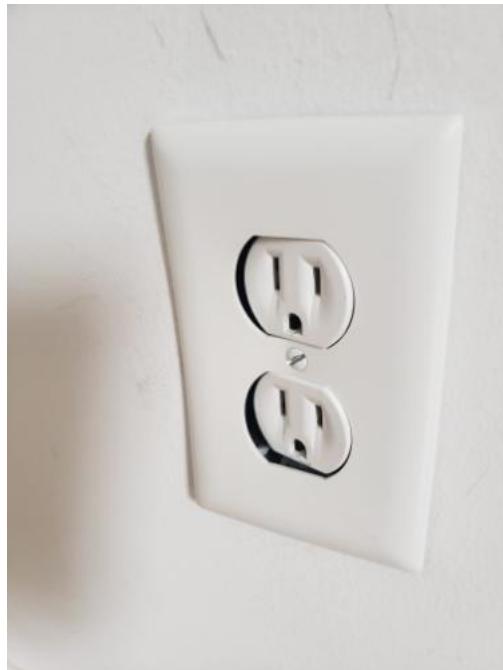
### 7.7) Electrical Conditions

One receptacle in bedroom needs reinstalled correctly It is suggested that a "Licensed Electrical Contractor" be contacted for further evaluation and repair.

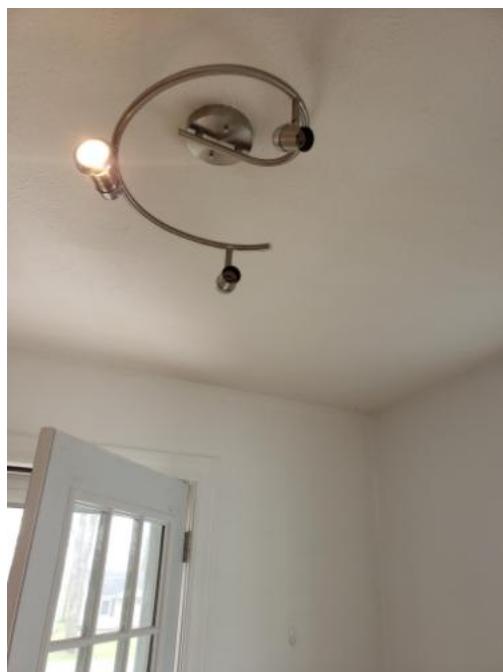
**7.8) Lighting Conditions**

Light bulbs were missing at front room fixture.

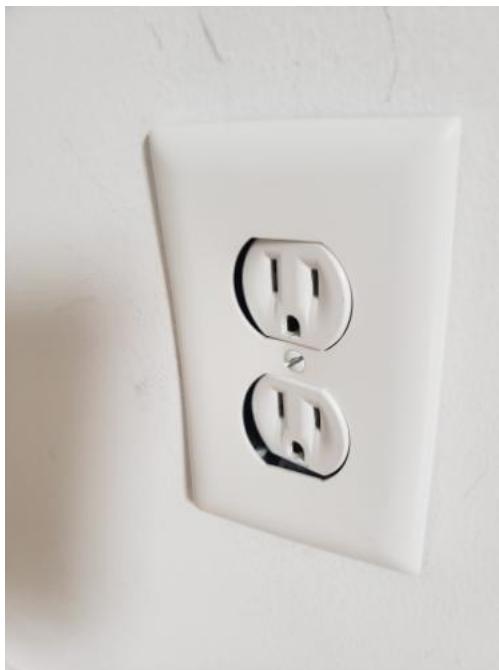
#### 8.7) Electrical Conditions

Previously mentioned loose / damaged outlet was observed at bedroom 1. Recommend further evaluation and repairs by a licensed electrician prior to close.

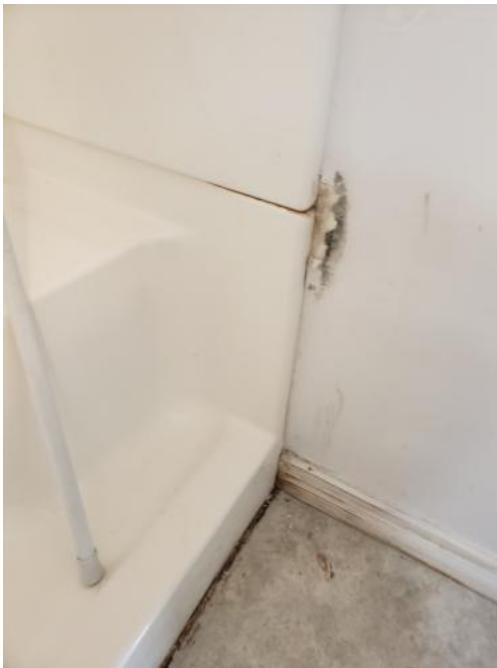
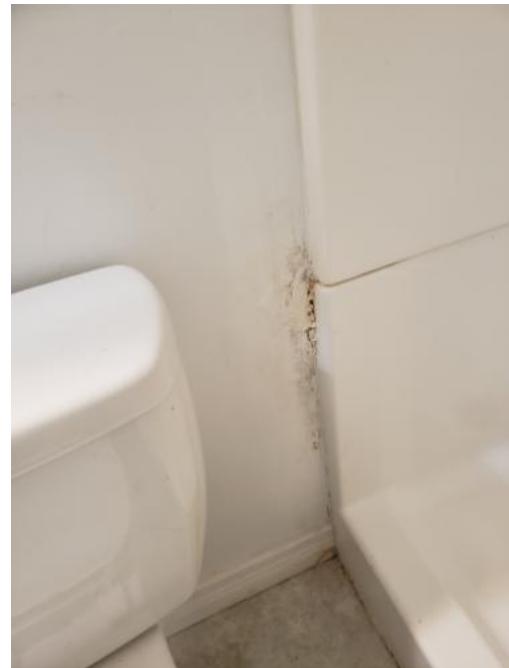
### 10.1) Wall Conditions

There were moisture stains on the walls adjacent to the shower insert. Recommend repair with moisture resistant materials.

Moisture related stains were observed at the bathroom ceiling. This was most likely caused by high humidity from showers. Please refer to limitations of inspection regarding moisture related conditions.

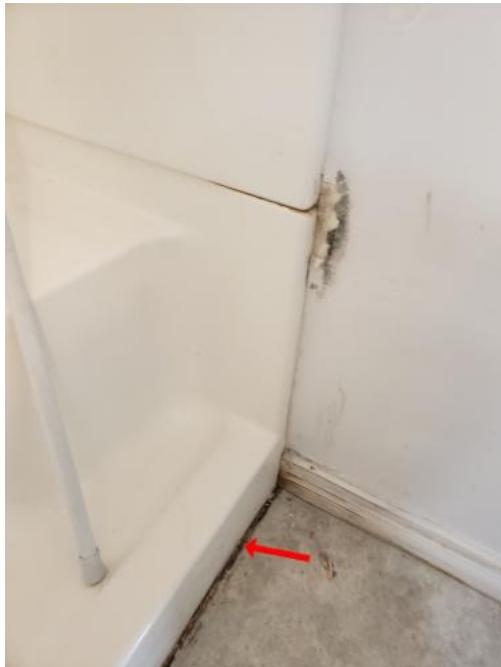
seal gap

Gap between floor covering and shower insert is allowing moisture intrusion beneath the floor covering. This area should be sealed up to prevent damage to subfloor.

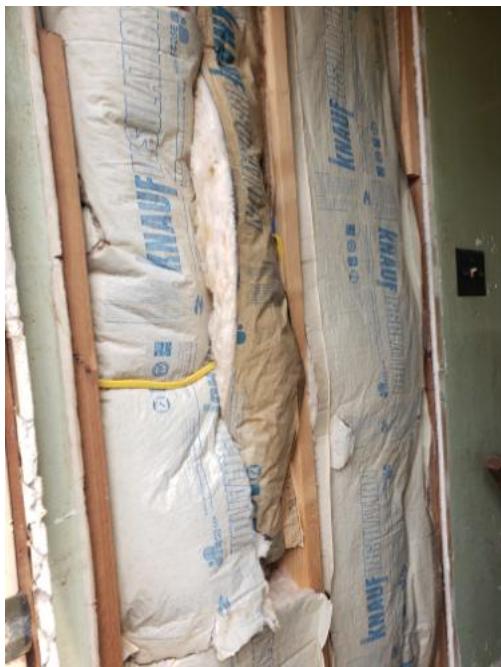
Wall board was missing at landing area, top of basement stairs.

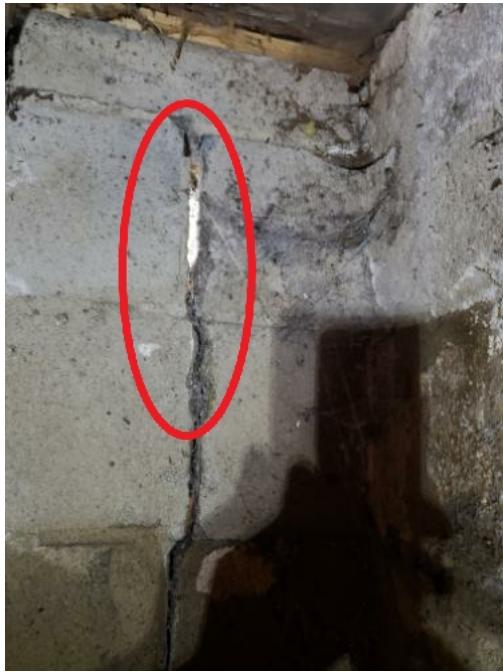
A crack of 1/8 " or more was observed in the foundation wall. The cracking implies that foundation movement has occurred. Recommend further review and inspection by a qualified foundation / masonry contractor and / or a qualified geo-technical or structural engineer. The exact / precise measurement of such conditions is not within the scope of our inspection. Past or future movement may be related to soils and geological issues, which are beyond the scope of our expertise.
